## Corrective Action Report

Corrective Action Report			
This report apply for: <input type="checkbox"/> System <input checked="" type="checkbox"/> Product <input type="checkbox"/> Process			Order Number: 122482
Inspector: Di Nan		Confirmed By: Liang Zhang	Issue Date: 2014.6.16
<b>General Information:</b>			
P.N. :	Description: BOSS, SENSOR OXYGE	Company: Nanjing Best International Co., Ltd..	Reject Rate: 9.63%
The reason for this report: <input type="checkbox"/> internal QA FAIL <input checked="" type="checkbox"/> Customer Inspection FAIL <input type="checkbox"/> Customer Complaint <input type="checkbox"/> others:			
Defect Problem Description: 1、Product surface crack 2、black spot on surface 3、surface embossing 4、rust (gate location)

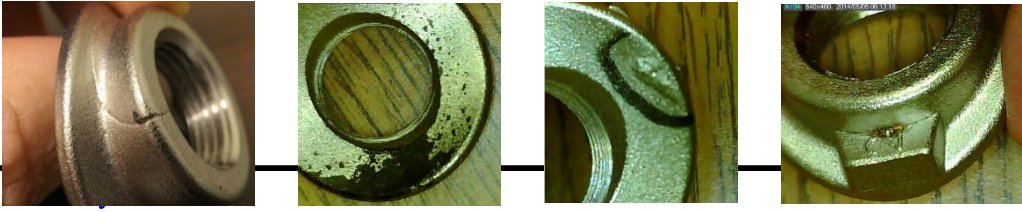
<b>1) Problem Definition and</b>			
<b>What</b> (what the problem is about, how describes it, what it is, etc)	1. there are cracks on surface and thread 2. Black spots exist on the product surface after nickel plating 3. surface has residual embossing 4. rust marks exist on the root of the gate location

<b>Problem Analysis</b> (Logic to conclude the root cause)	<ol style="list-style-type: none"> <li>1. Cooling speed of castings is uneven/too fast, causing shrinkage cracks</li> <li>2. Shell mould cracks</li> <li>3. Mold damage, the surface has a pit</li> <li>4. Wax models convex or shell mould concave</li> <li>5. Plated surface drying is inadequate</li> <li>6. Cracks/porosity/sand holes at gate location</li> </ol>
<b>Root Cause</b>	<ol style="list-style-type: none"> <li>1. Cooling speed of castings is uneven/too fast, causing shrinkage cracks</li> <li>2. Wax models convex or shell mould concave</li> <li>3. Cracks/porosity/sand holes at gate location</li> <li>4. Plated surface drying is inadequate</li> </ol>
<b>Root Cause Verification</b> (Verify through Experimentation that the root cause detected could provoke that the problem shows up or not)	<ol style="list-style-type: none"> <li>1. Cooling speed of castings is uneven/too fast, causing shrinkage cracks</li> <li>2. When wax making, wax hanging and casting slag splashing</li> <li>3. Cracks/porosity/sand holes at gate location</li> <li>4. Plated surface drying is inadequate</li> </ol>

1. Optimization of casting mould, increase the gate connection area
2. Increase the sprinkle sand layer
3. Control the cooling speed of castings, and make it completely natural cooling
4. Technology training on new casting workers
5. To strengthen quality management of outsourcing factory
6. To strengthen the inspection of product surface/full inspection
